Inspection Report

Property Address:
329 Doerun Rd
Doerun Ga 31744

South Georgia Home Inspections

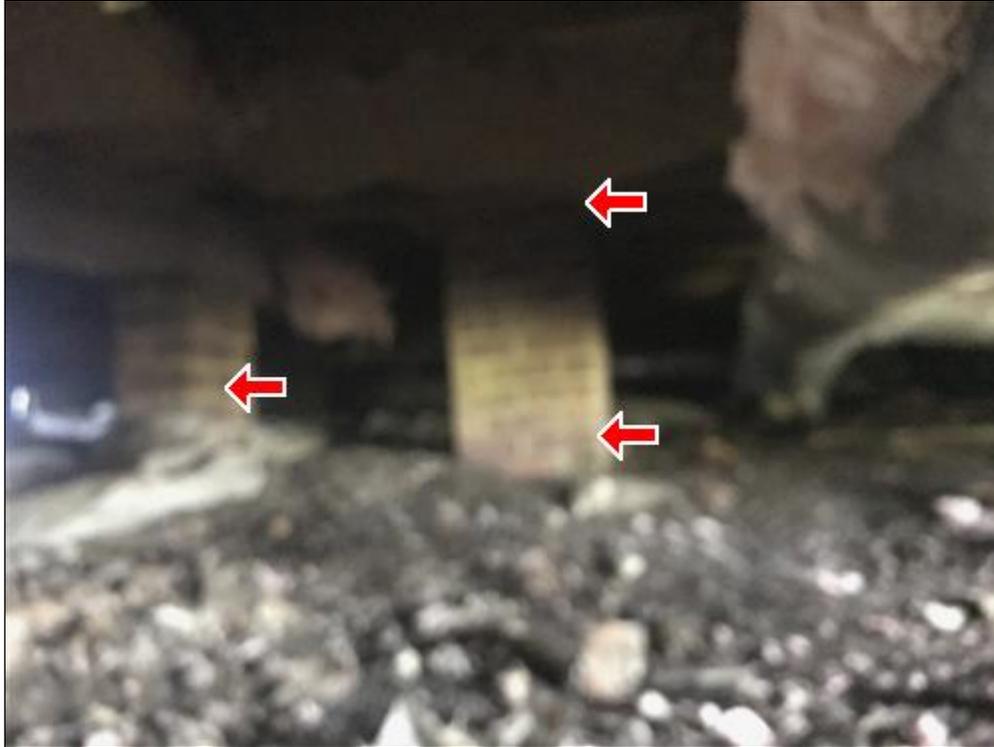
B. Picture 1

B. Some of the brick piers are leaning in areas, block piers have been added, however these mason blocks do not a proper footing underneath them.. Some are leaning.

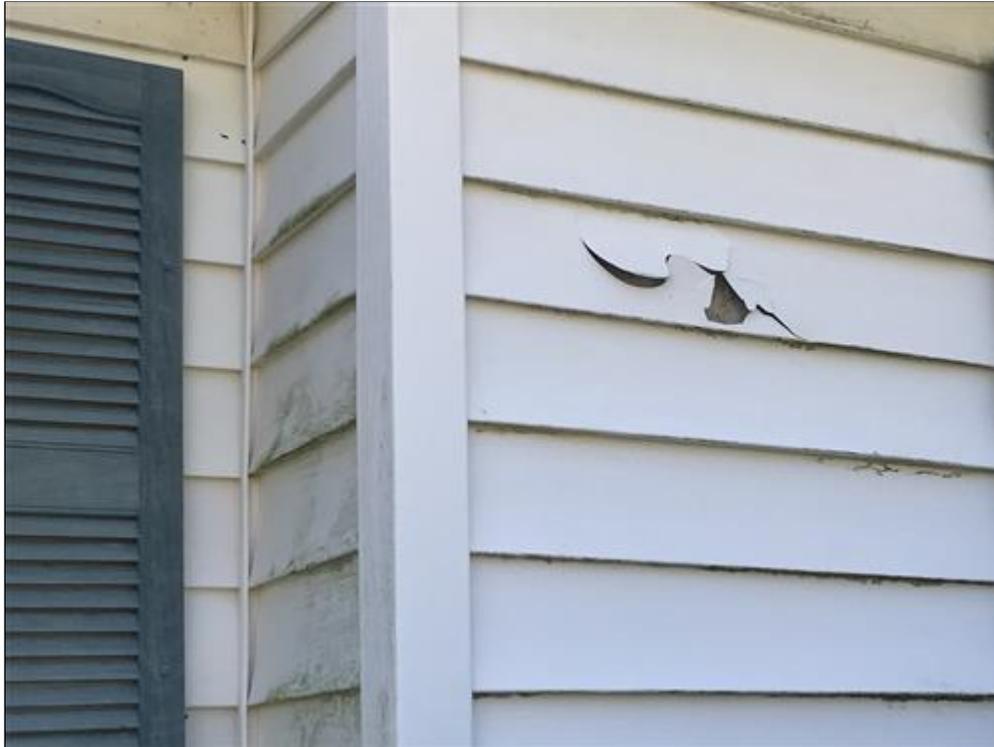
F. Picture 1

F. (1) The Vinyl siding at the exterior in areas is damaged. . A qualified person should repair or replace as needed.

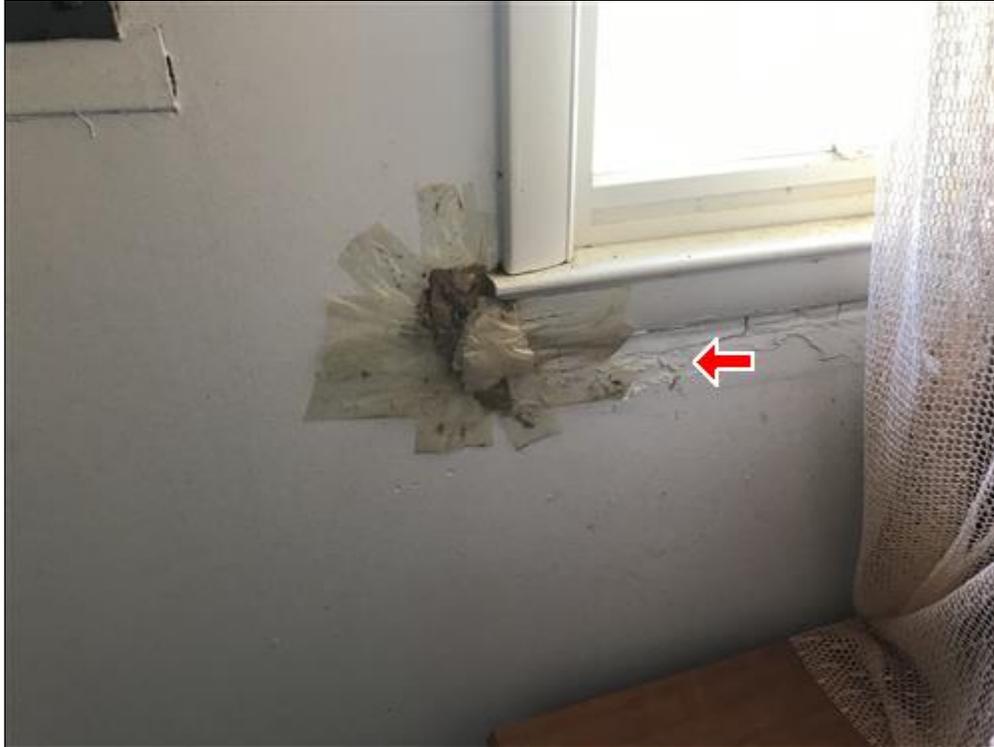
(2) The sheetrock on the wall is damaged at the Bedroom. While this damage is cosmetic, it needs to be repaired..

F. Picture 3 Window leaking in this area , replacment maybe needed.

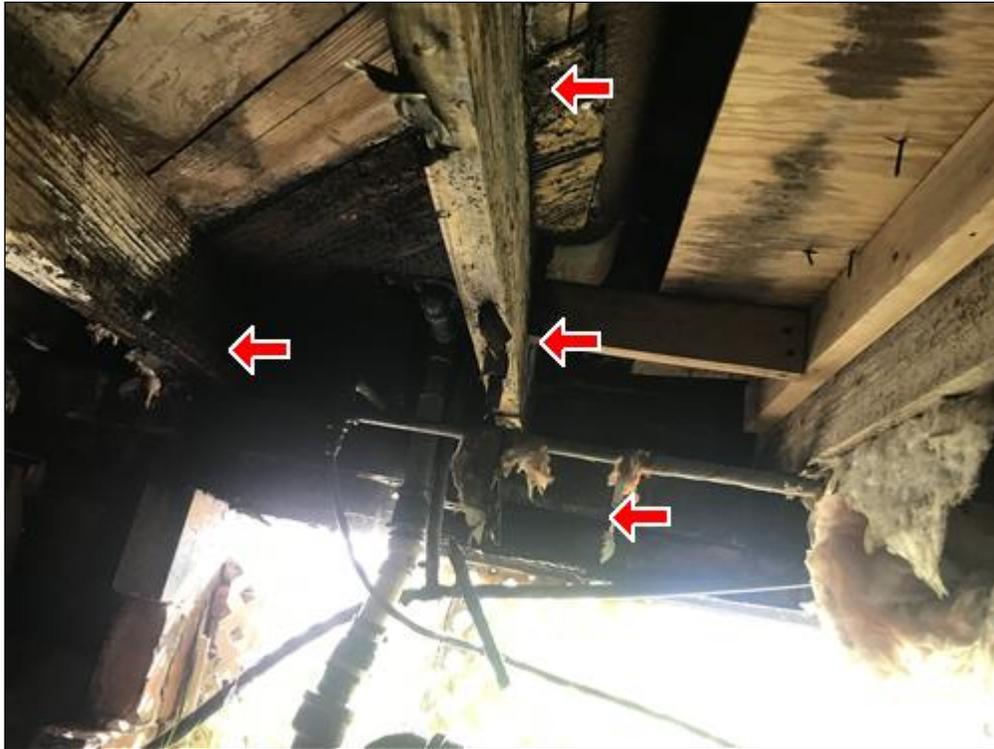
G. Picture 1

G. (1) Sub-flooring and floor joist(s) and main sill plate are deteriorated from moisture absorption or water intrusion under the Hall Bath. Repairs are needed.

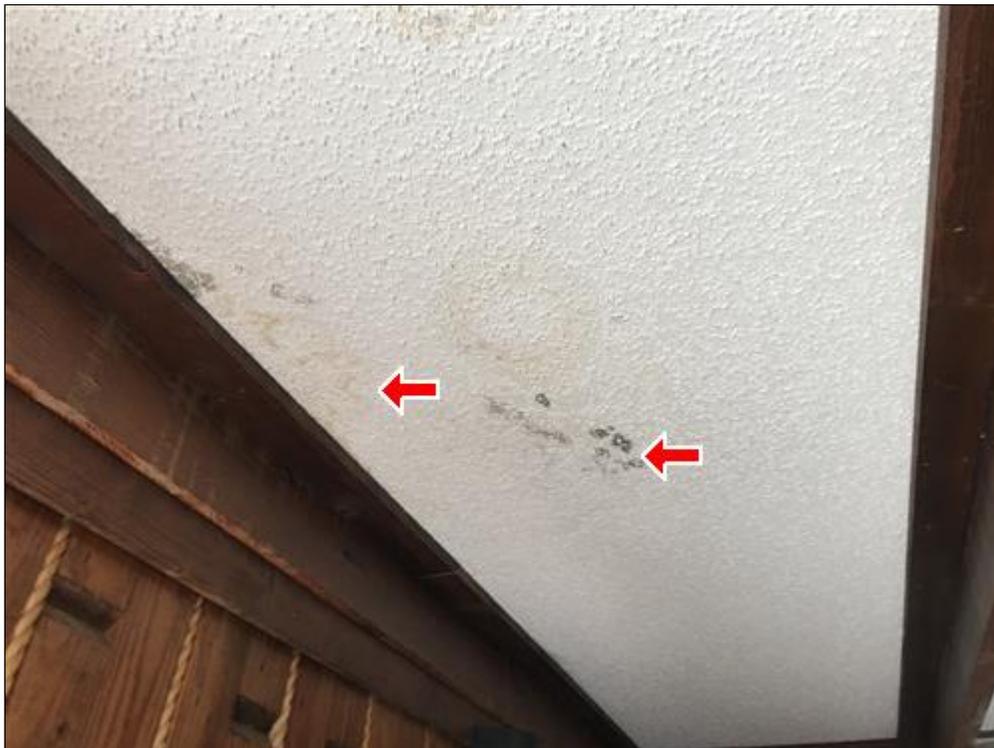
G. Picture 6

(3) The Sheetrock on the ceiling is damaged at the Washer/Dryer room. While this damage is cosmetic, it needs to be repaired. A qualified person should repair or replace as needed.

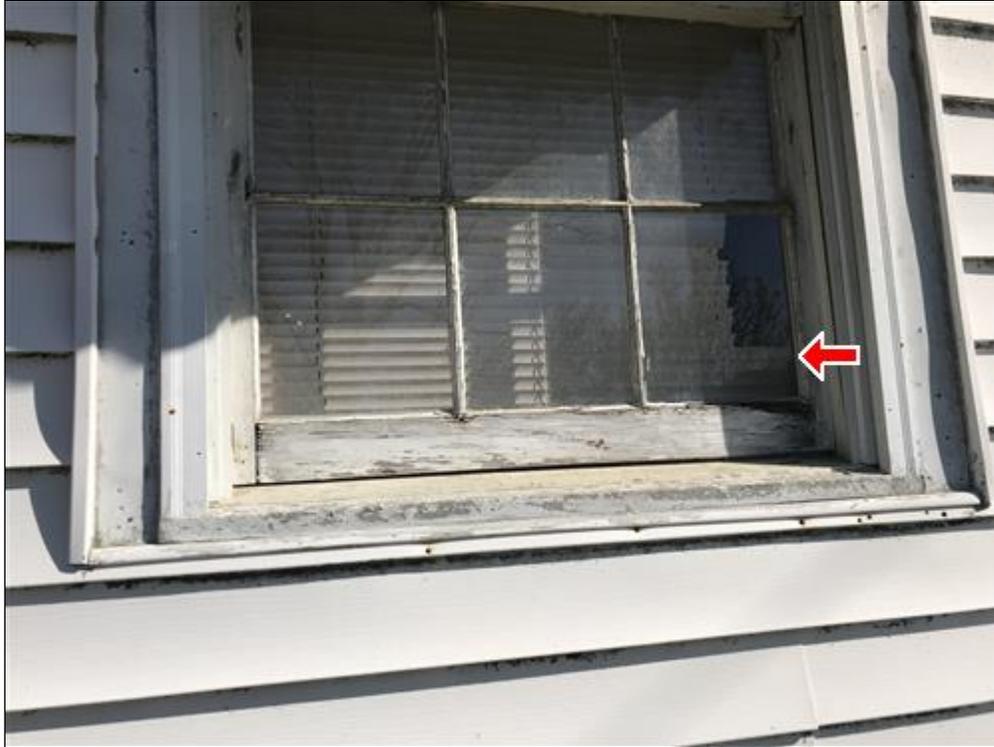
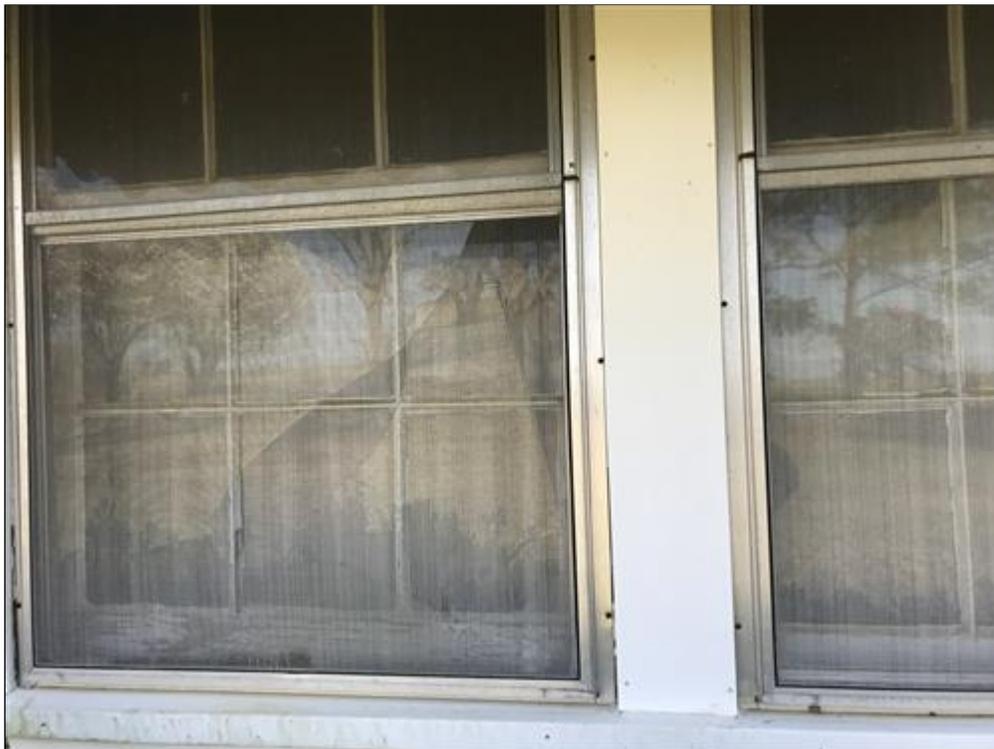
(2) There are cracked glass in some windows throughout home.

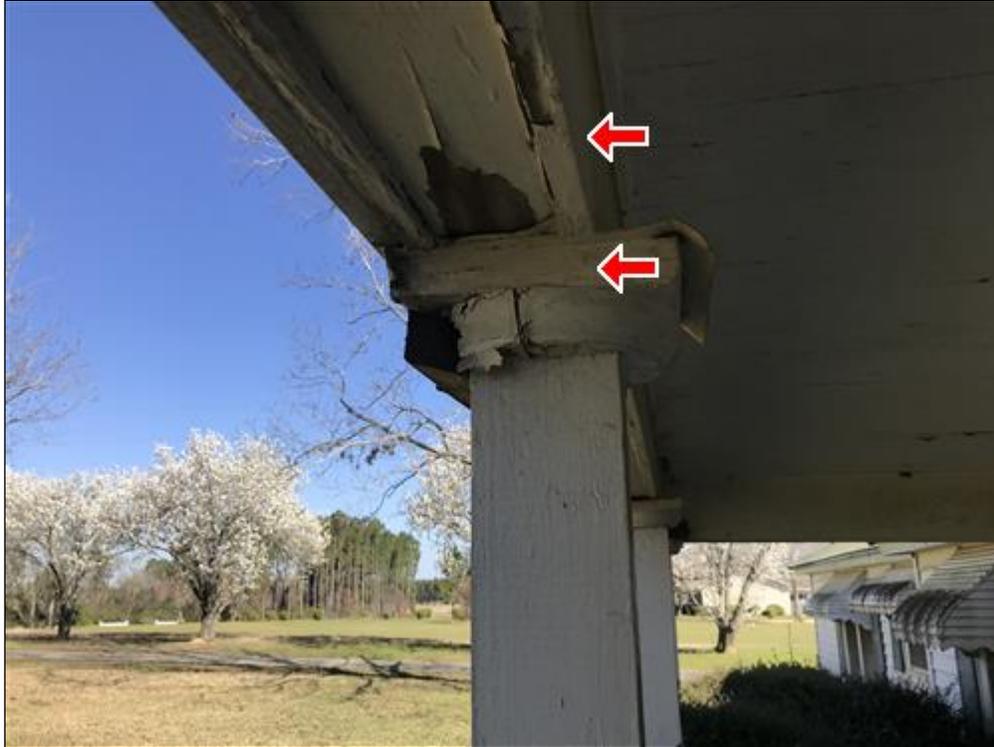
K. Picture 1

K. The front porch support header is starting to deteriorate, further deterioration will occur if not corrected. A qualified person should further investigate and repair as needed.

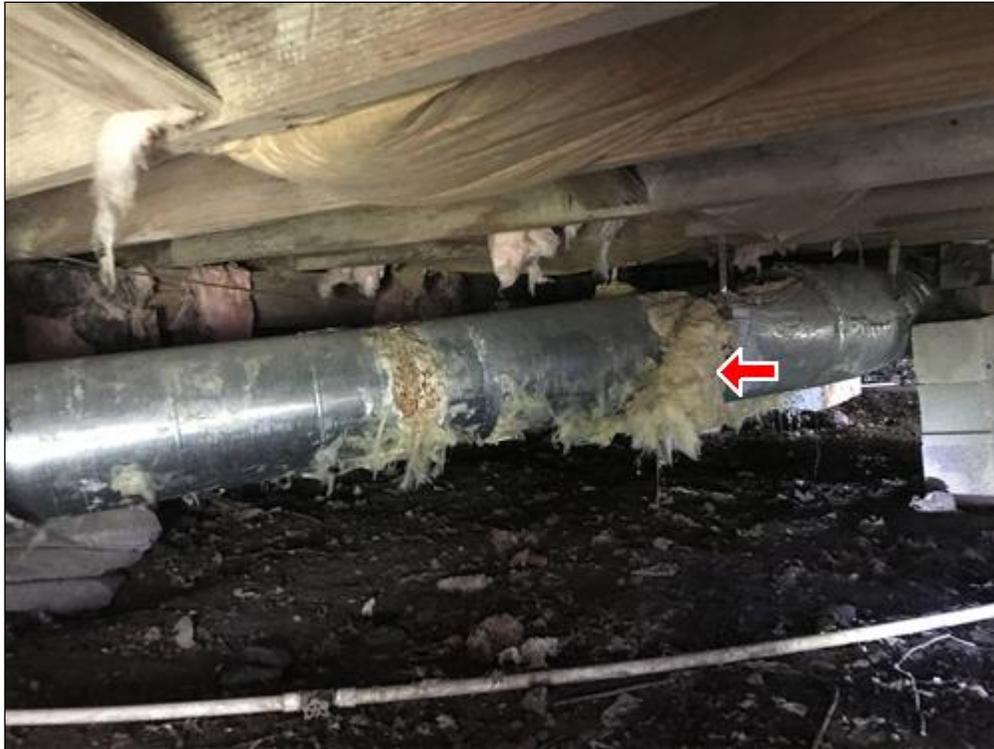
C. Picture 1

C. The duct pipe insulation is loose in the crawlspace. Energy loss is occurring in crawlspace and immediate correction is needed. .

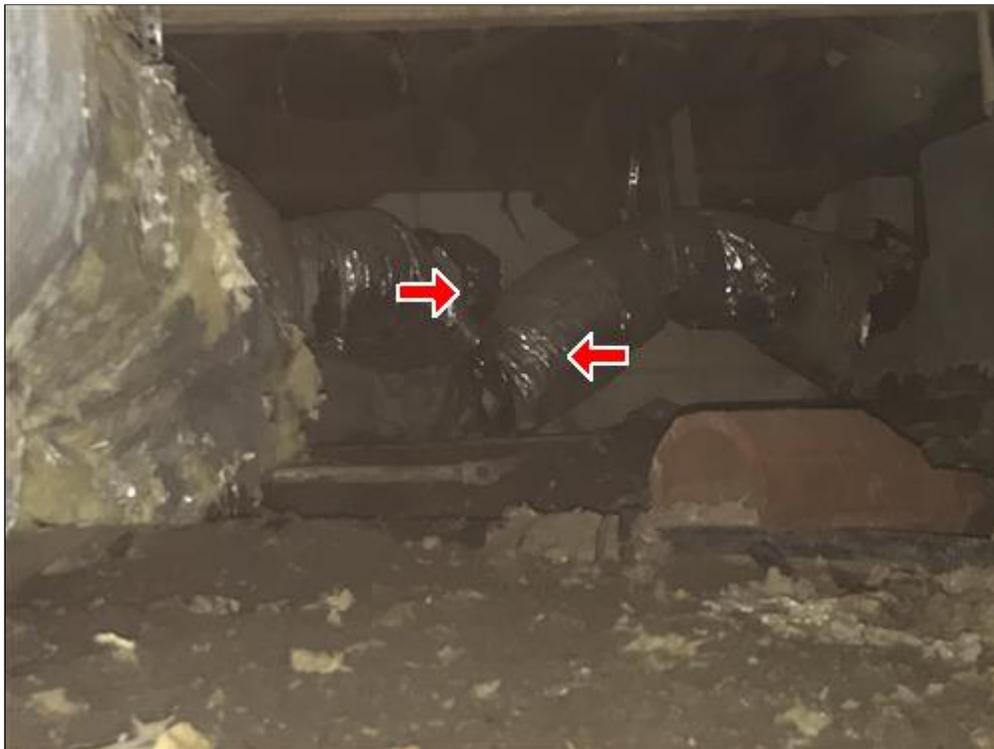
C. Picture 2 Dis connected duct work in the crawlspace

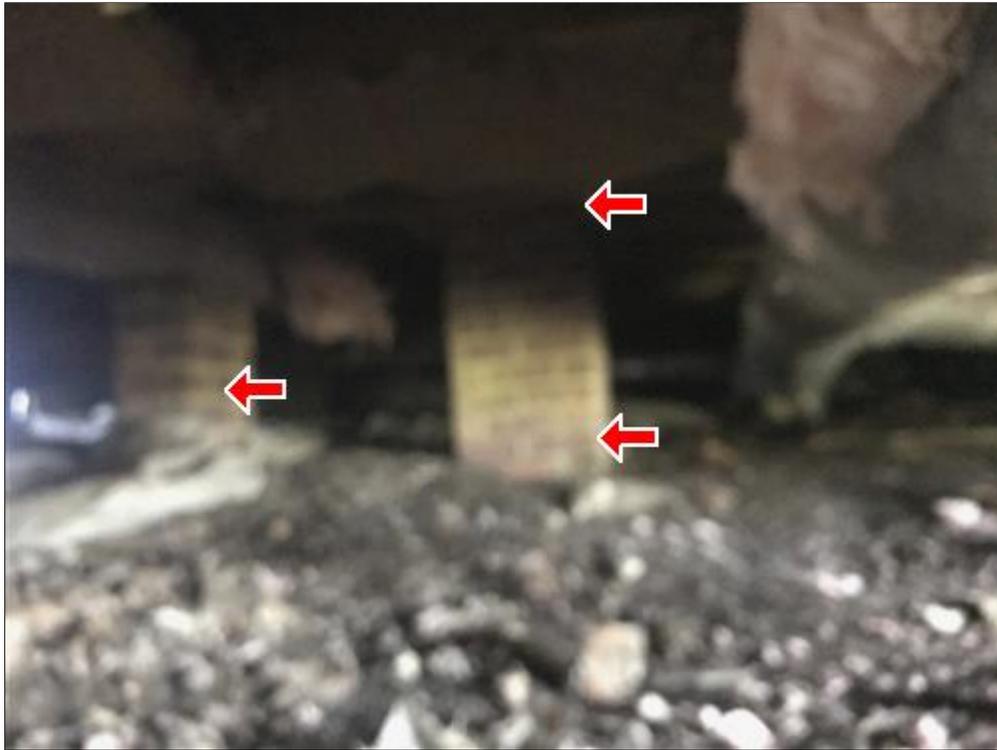
B. Picture 1

Some of the brick piers are leaning in areas, block piers have been added, however these mason blocks do not a proper footing underneath them.. Some are leaning.

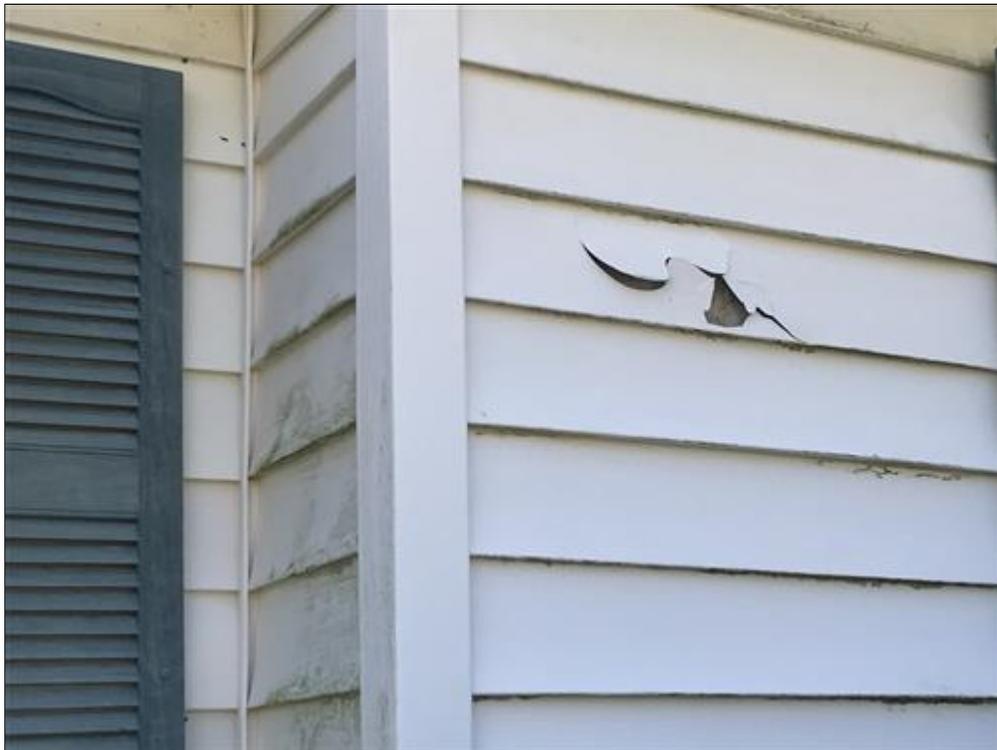
F. Picture 1

(1) The Vinyl siding at the exterior in areas is damaged. . A qualified person should repair or replace as needed.

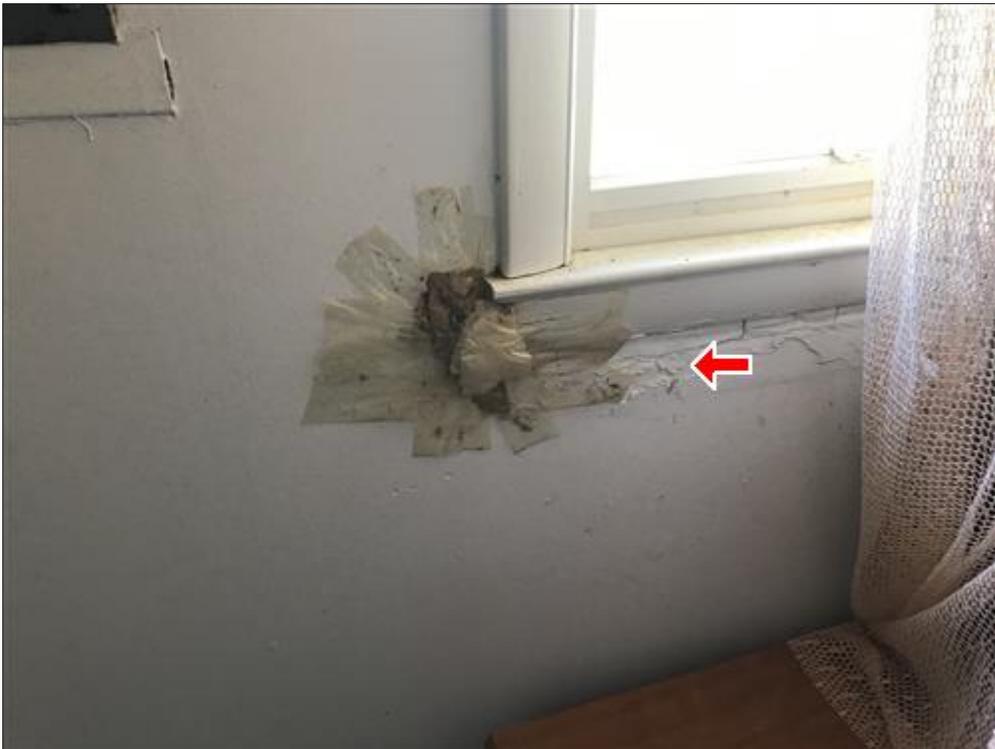
(2) The sheetrock on the wall is damaged at the Bedroom. While this damage is cosmetic, it needs to be repaired..

F. Picture 3 Window leaking in this area , replacment maybe needed.

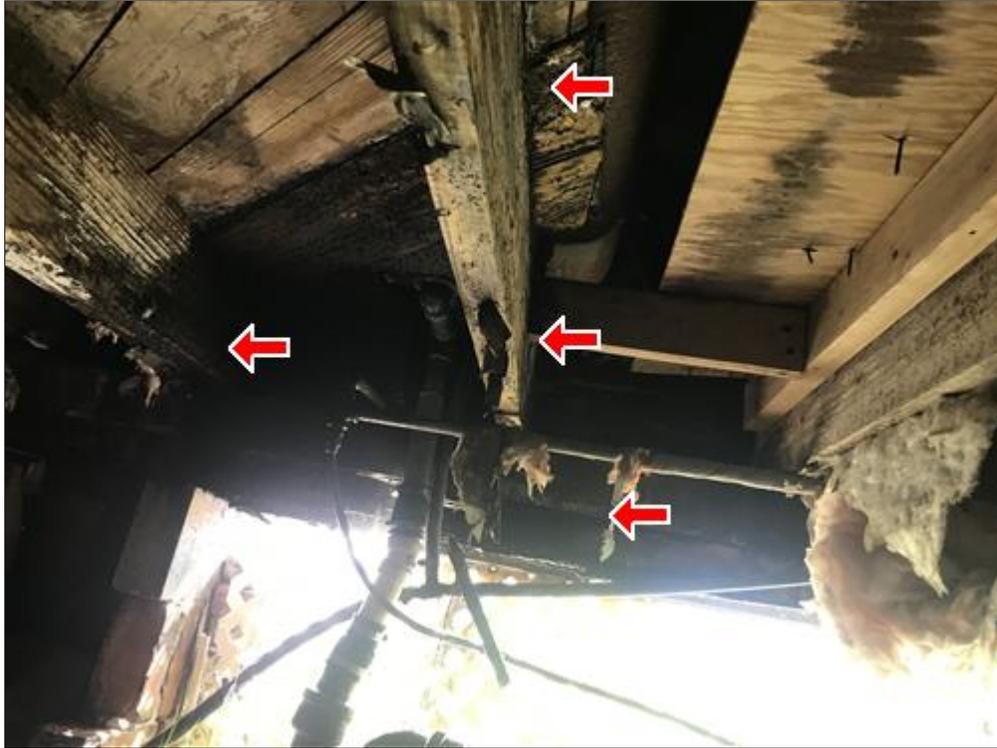
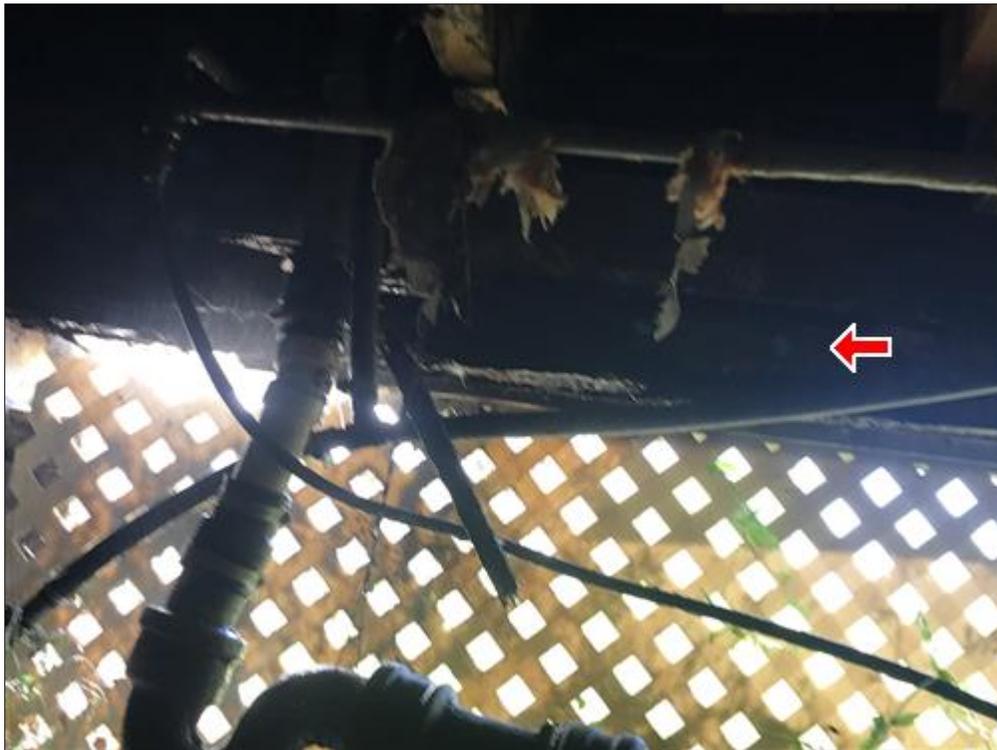
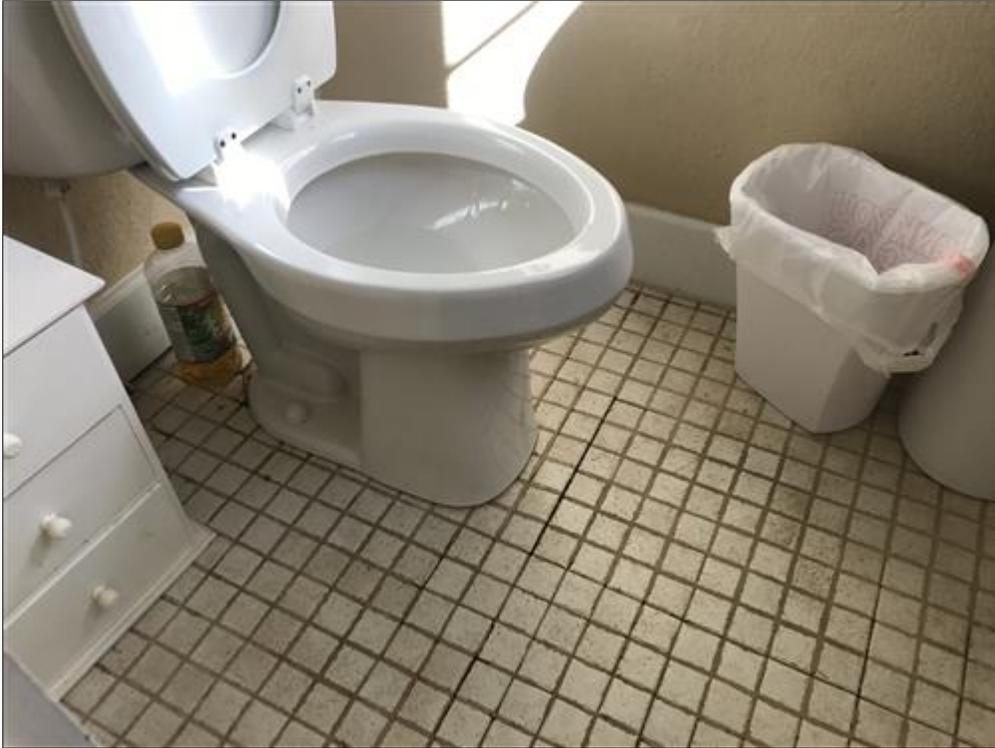
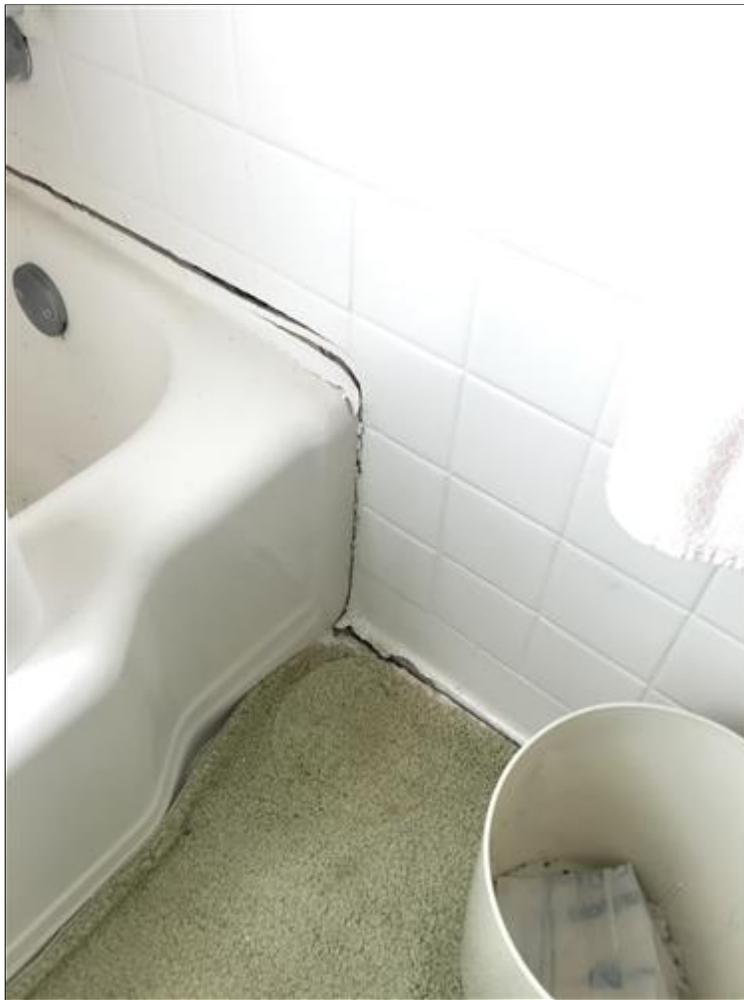
(1) Sub-flooring and floor joist(s) and main sill plate are deteriorated from moisture absorption or water intrusion under the Hall Bath. Repairs are needed.

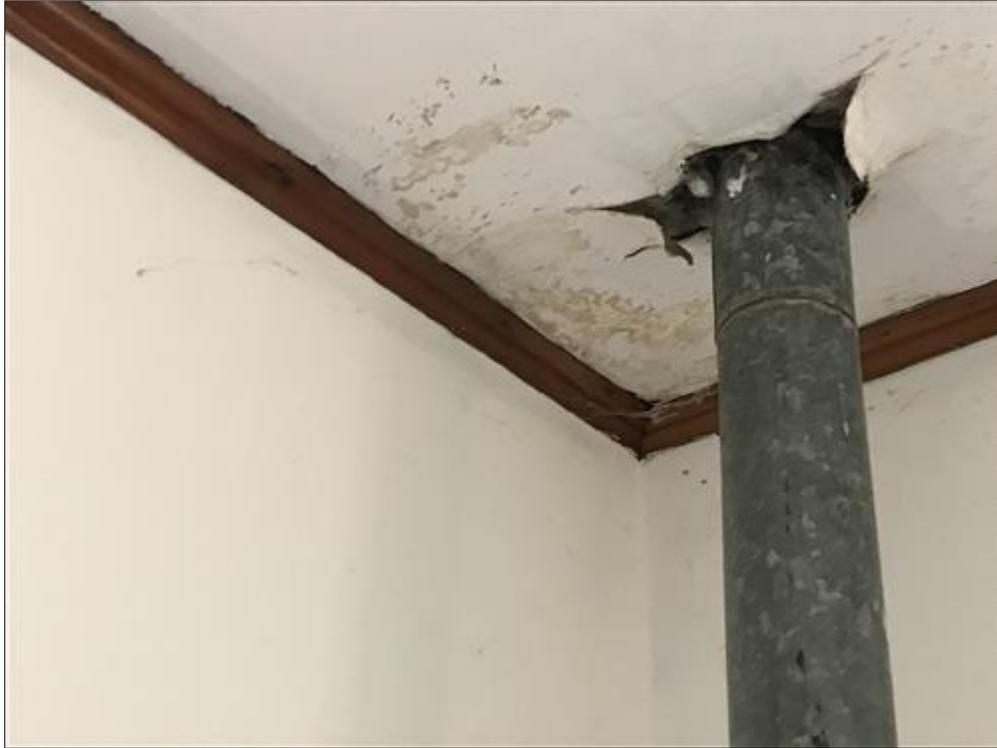
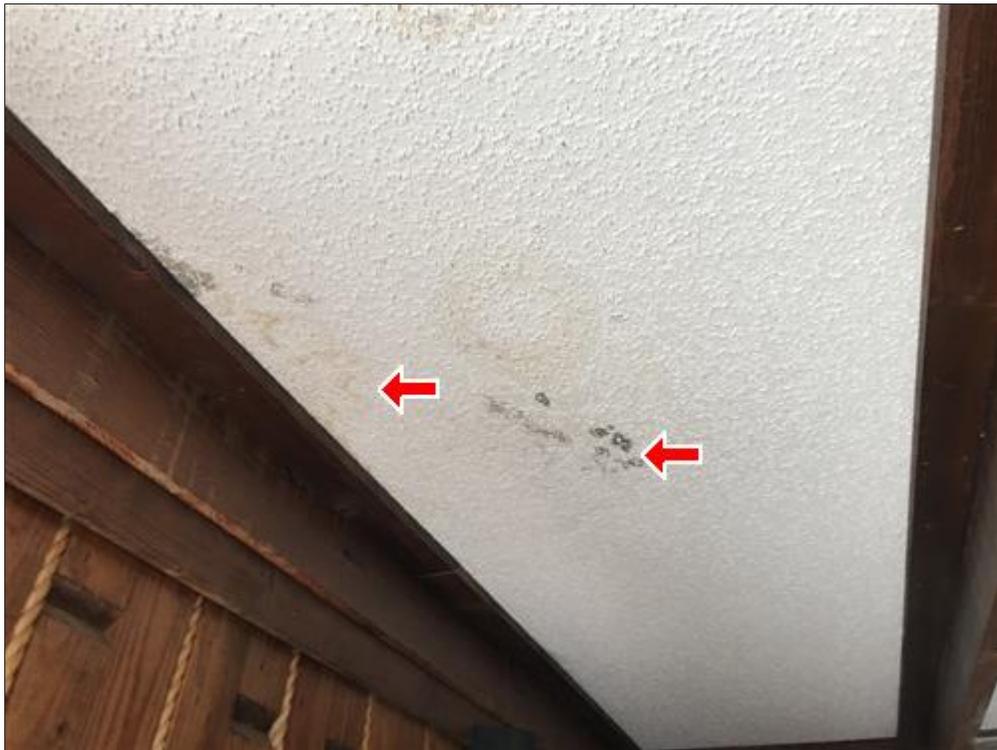
- (2) Tile is damaged Sub floor is deteriorated in this area at the hall bath. While this damage is cosmetic, the repair cost should be considered due to the amount of damage.
- (3) The Sheetrock on the ceiling is damaged at the Washer/Dryer room. While this damage is cosmetic, it needs to be repaired. A qualified person should repair or replace as needed.

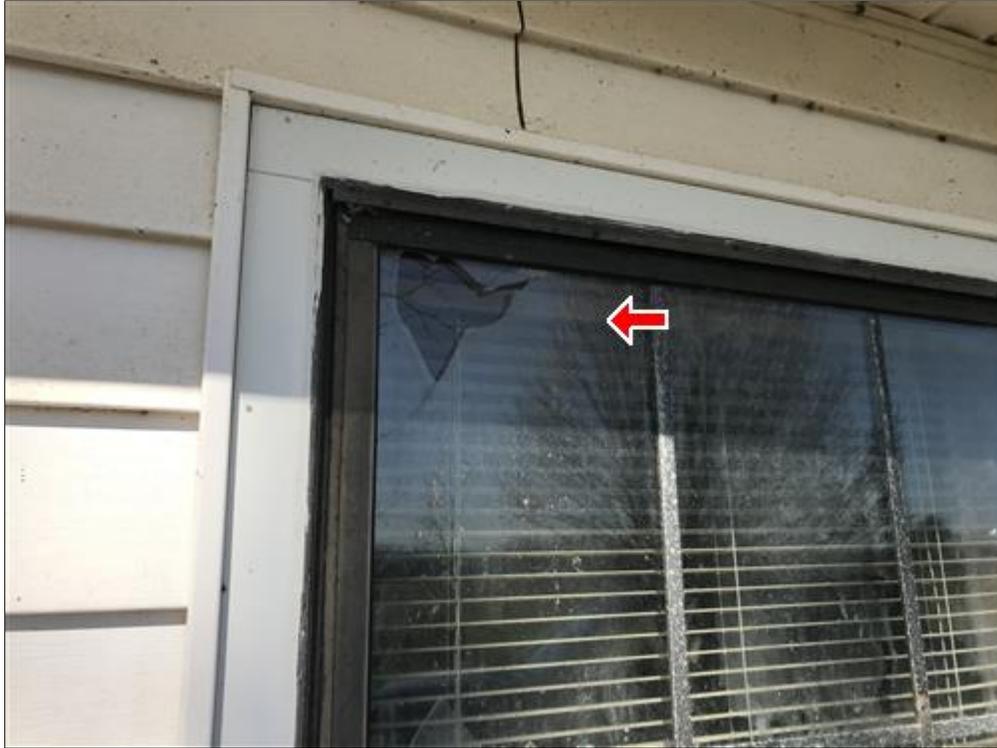
I. Picture 1

(1) The wood trim is peeling paint at most windows. Further deterioration may occur if not repaired. I prep and paint and as needed.

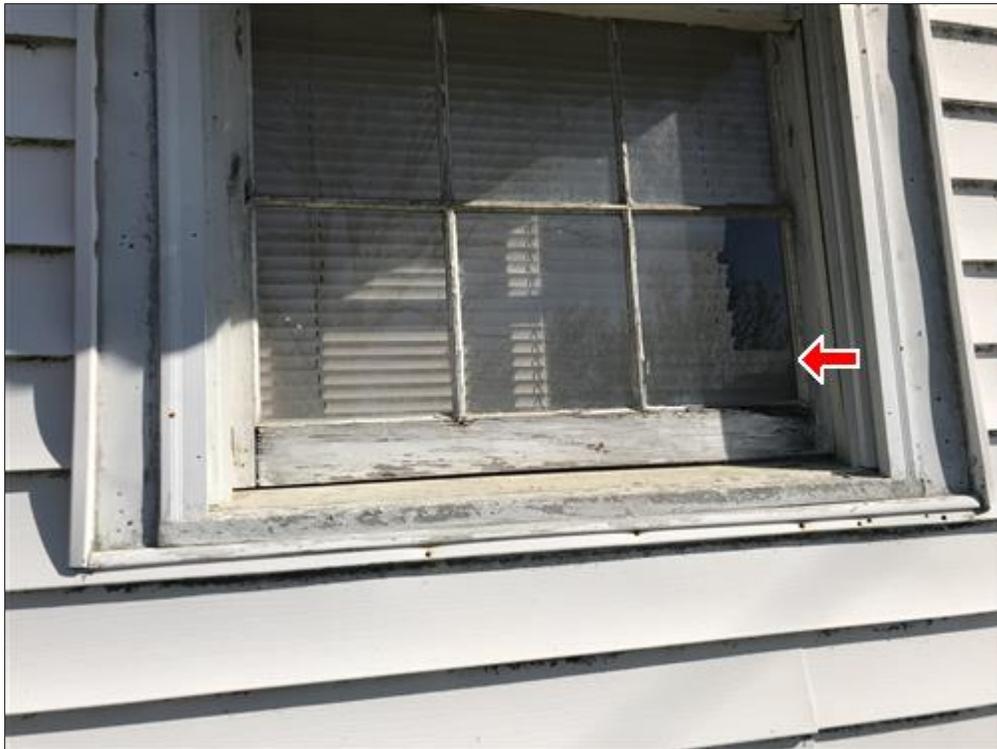
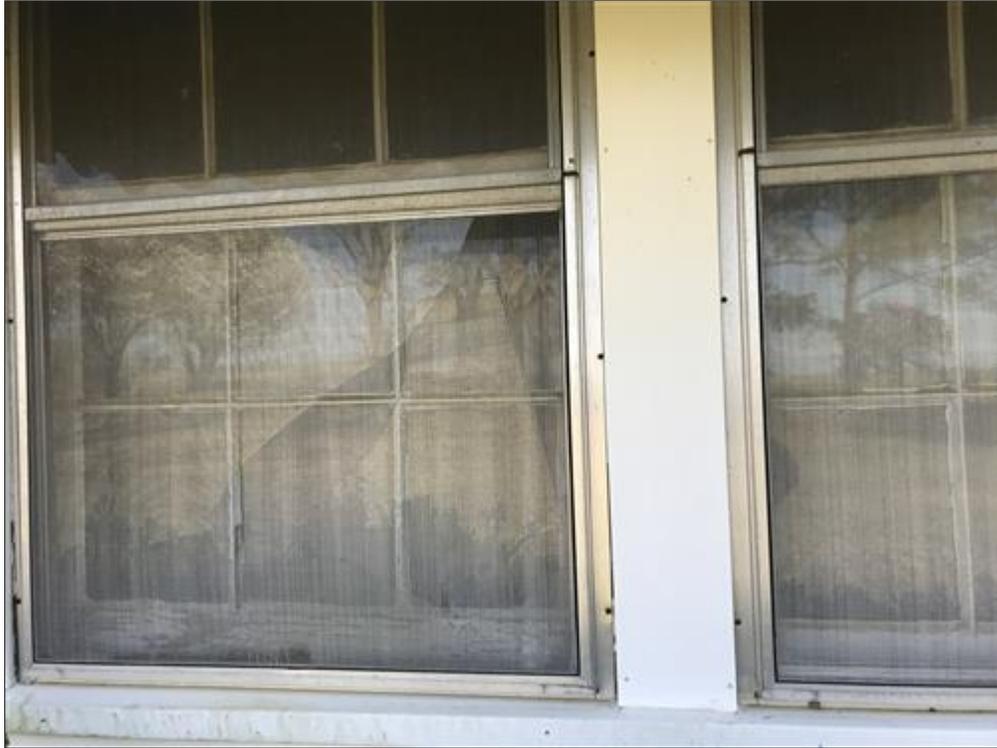
(2) There are cracked glass in some windows throughout home.

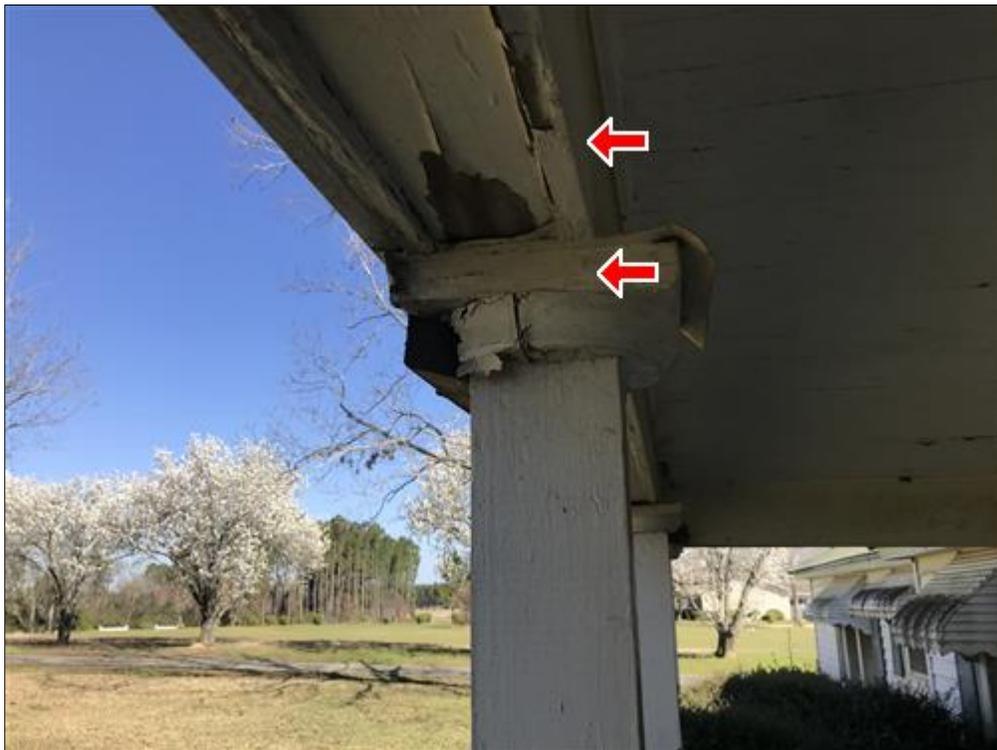
K. Picture 1

The front porch support header is starting to deteriorate, further deterioration will occur if not corrected. A qualified person should further investigate and repair as needed.

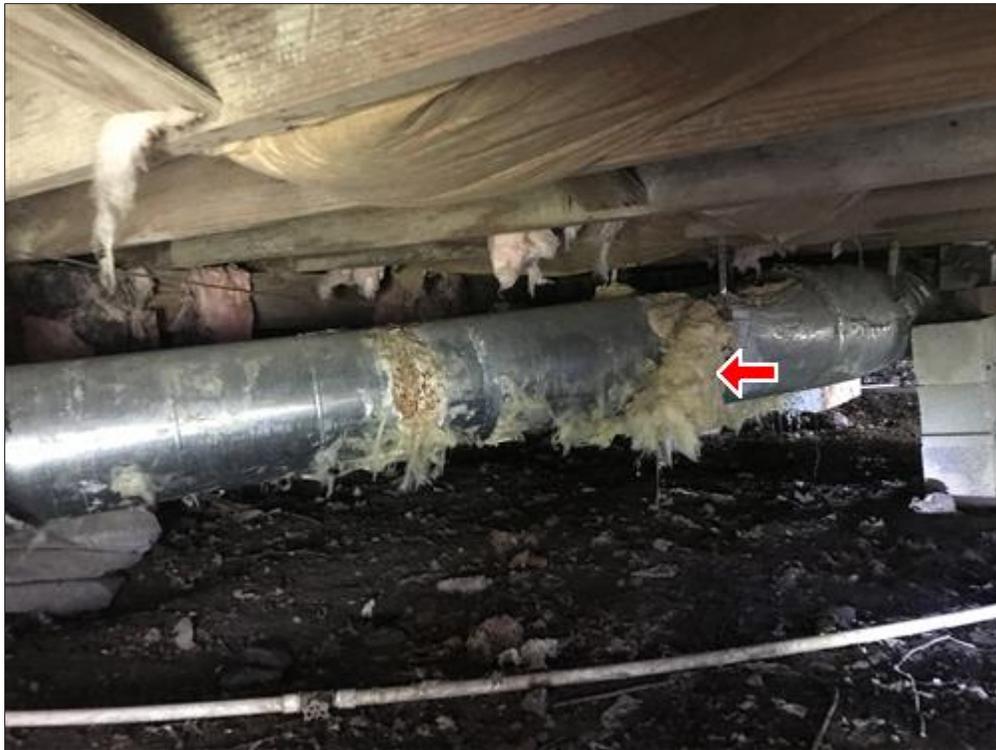
C. Picture 1

The duct pipe insulation is loose in the crawlspace. Energy loss is occurring in crawlspace and immediate correction is needed. .

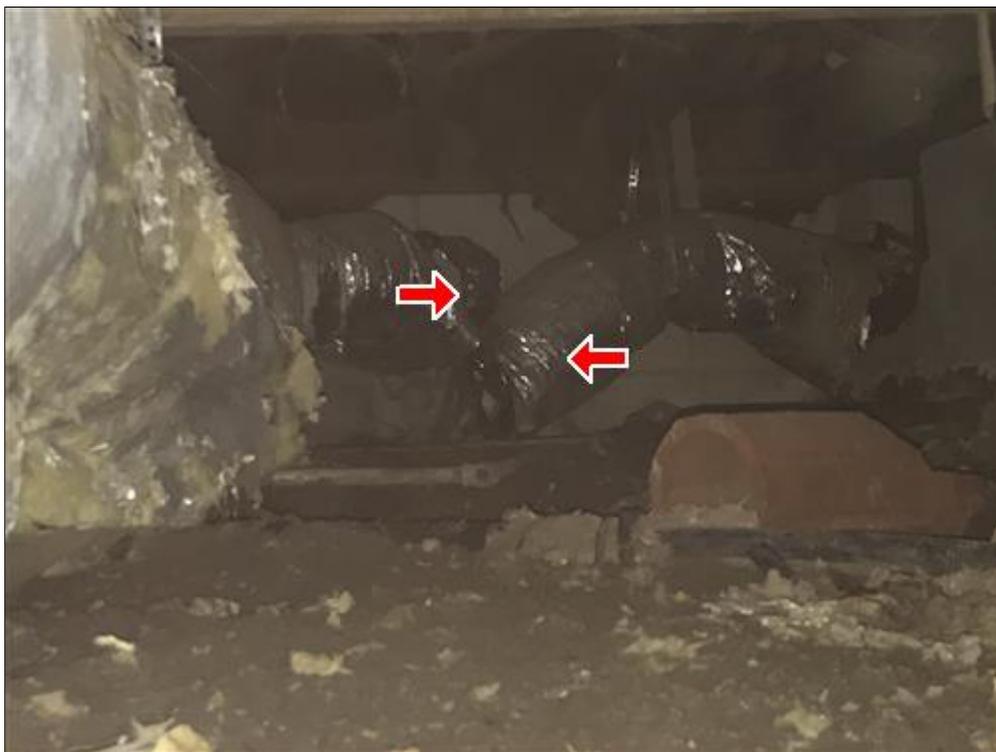
C. Picture 2 Dis connected duct work in the crawlspace
